CRASH TESTING OF VARIOUS TEXTURED BARRIERS

DEPARTMENT OF TRANSPORTATION
ENGINEERING SERVICES
MATERIALS ENGINEERING AND TESTING SERVICES

September 2002

1. REPORT NO. FHWA/CA/TL-2002/03	2. GOVERNMENT ACCESSION NO.	3. RECIPIENT'S CATALOG NO.	
4. TITLE AND SUBTITLE CRASH TESTING OF VARIOUS TEXTURED BARRIERS		5. REPORT DATE September, 2002

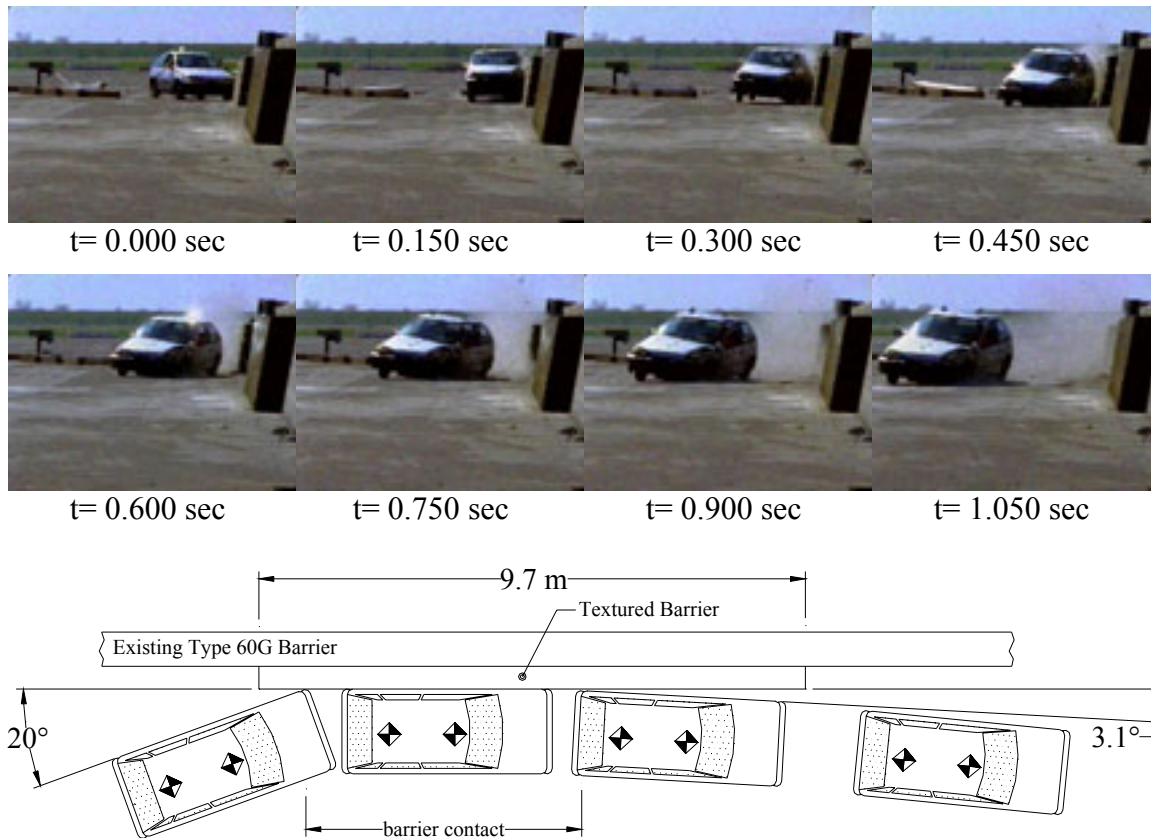
Figure 2-9 Impact sequence and diagram for Test 581

Test Barrier:	Type: 1220-mm high, deep cobble textured barrier with a Type 60 profile Length: 9.75-m total length Test Date: March 14, 2001
Test Vehicle:	Model: 1991 Chevrolet Sprint Inertial Mass: 823.0 kg Impact / Exit Velocity: 97.4 km/h / 78.0 km/h Impact / Exit Angle: 20.1° / < 3.5°
Test Dummy:	Type: Hybrid III Weight / Restraint: 74.8 kg / lap and shoulder belt Position: Front Left
Test Data:	Occ. Impact Velocity (Long / Lat): 5.62 m/s / -6.81 m/s Ridedown Acceleration (Long / Lat): -7.96 g / 9.22 g ASI: 1.65 Exterior: VDS ⁽³⁾ /CDC ⁽⁴⁾ LFQ-4, LD-1 / 11LDMW2 Interior: OCDI ⁽¹⁾ x1x0101 (components a and c were not available)
Barrier Damage:	Minor scrapes, gouges, and chipping on some cobbles. The barrier would not require immediate repair.

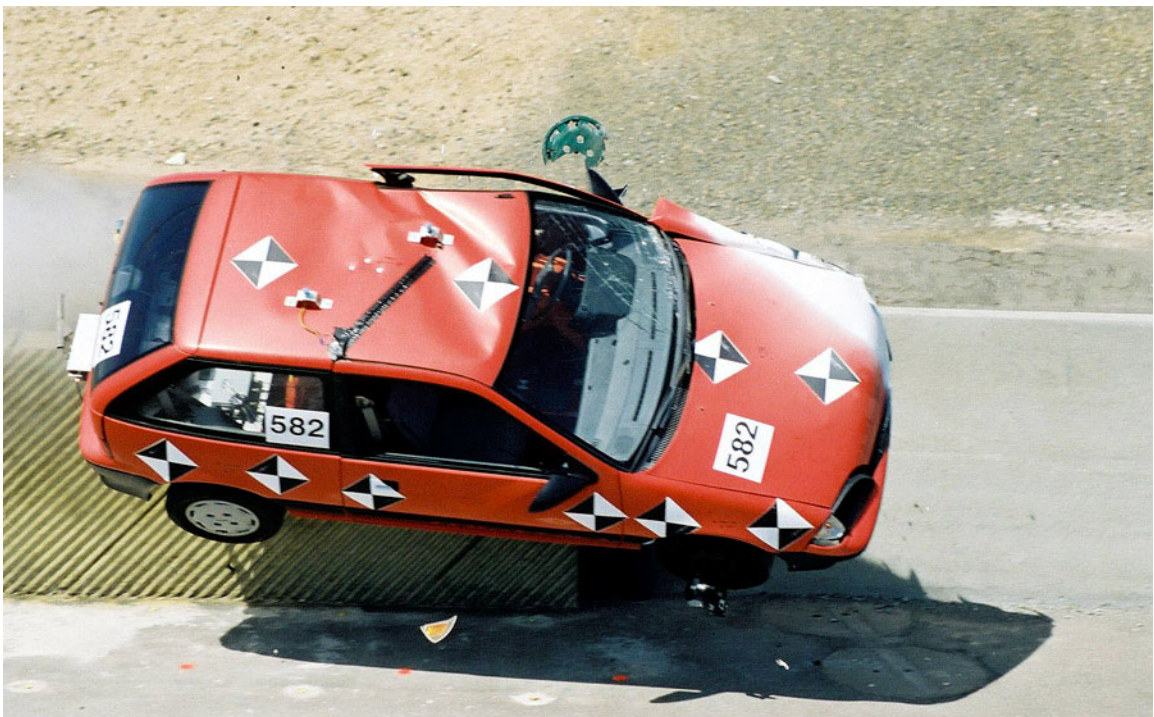
Figure 2-12 Test vehicle 582 during the Test
(the vehicle rolled over twice to the left after landing)

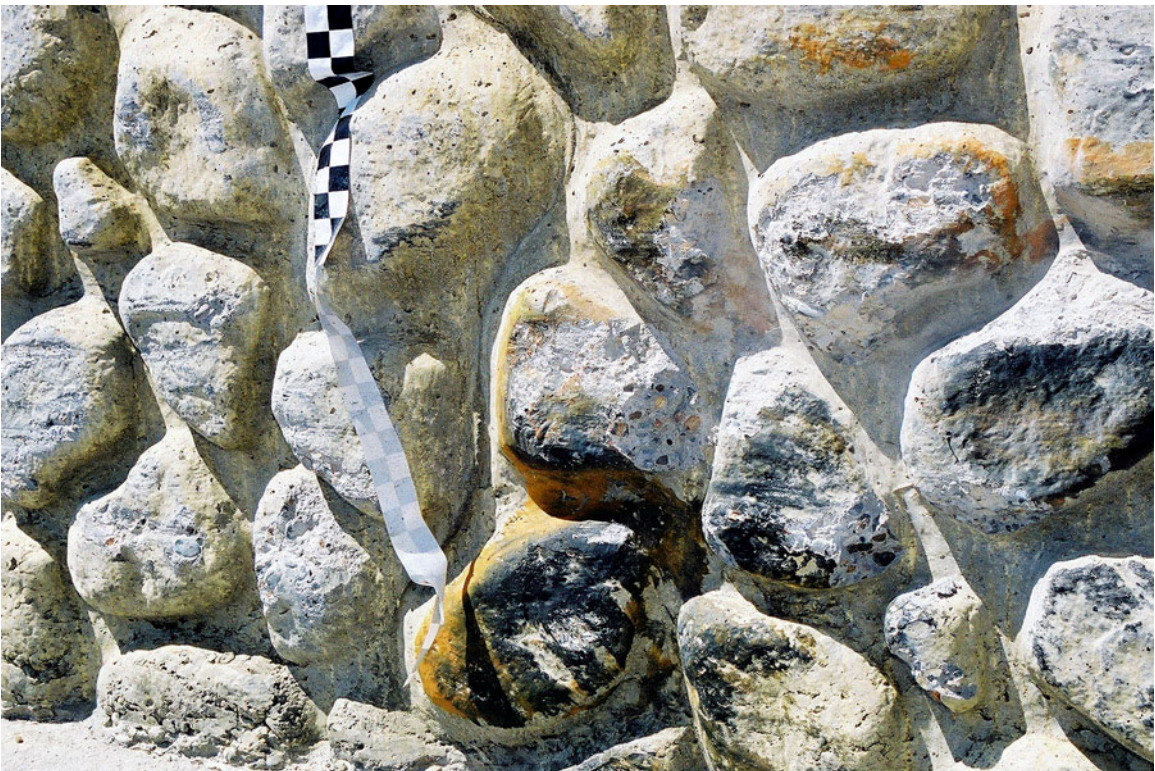
Figure 2-22 Test article after Test 583 (at impact point)

Most of the damage to the barrier was superficial scraping and gouging. The vehicle impact caused some edges of individual cobbles to chip or break off (Figure 2-21 and Figure 2-22). The barrier would not require immediate repair. The gouges and scrapes could be filled on-site by maintenance crews.
